Install Guide Rear Live-adjustable Control Arms

Application - Tesla Model 3 / Y - models 2017-on

Contents - 2x live adjustable control arms

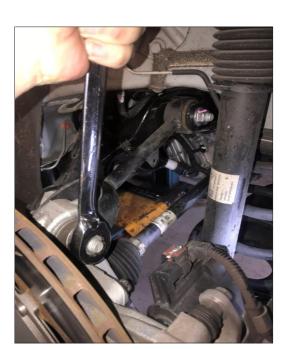
- Next remove the series of 10mm bolts from the rear section black plastic under-tray.
- Start to Un-bolt original control arm, using either 18mm or 21mm spanners.
- All original bolts will be re-used.

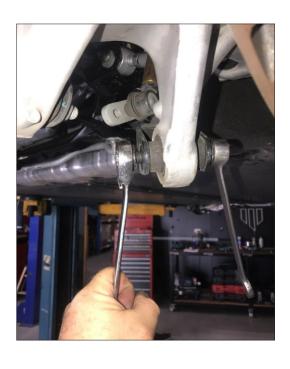
- with performance bushings
- (KTA326 / 327 / 328 / 329)
- Raise vehicle evenly and safely support with a hoist or stands.

Never rely on a Jack only

Proceed to remove rear wheels.

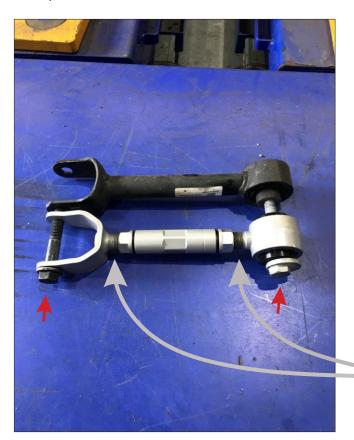
- Next, line the original arm up with the new adjustable unit.
- Use the original bolts to match length with original arm.

IMPORTANT - check there is similar thread exposed at both ends of adjustable arm

Refer LH image.

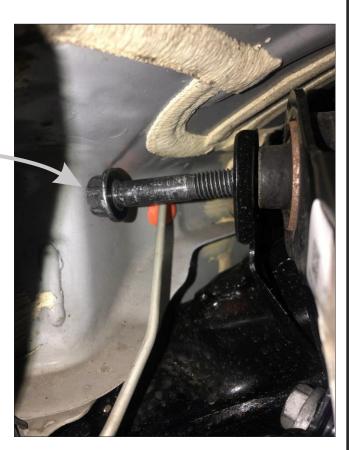
NOTE - for the upper front arm **(KTA328)** lowering of the sub-frame slightly will be required to remove the inner bolt, due to it hitting the floor - refer RH image.

Loosen the 4 main sub-frame bolts approx. 15mm (no need to remove bolts completely).

Using a pry bar with timber, have a 2nd person push sub-frame towards the rear while you attempt to un-wind/remove the bolt.

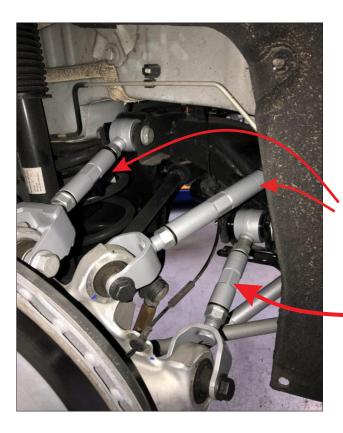
- Refer LH image with 3 sets of arms installed. (KTA326/327/328)
- **Note** for <u>proper camber adjustment</u>, BOTH upper arms will be required (KTA326 and KTA328) both arms need to be adjusted simultaneously.

The very front "Toe" arm (KTA327) should also be checked while adjusting camber.

IMPORTANT - vehicles with excessive negative camber - check drive shafts have sufficient end float to prevent any drive-line damage.

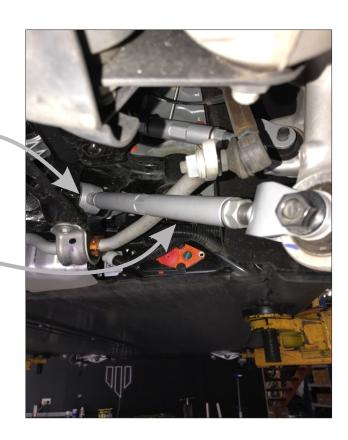
- Grease bushing internal diameter with supplied grease. Grease bushing face also. Lastly push steel tube back in.
- Proceed to bolt up new adjustable arms using original bolts.

Lower trailing arm pictured here - (KTA329)
